*Comprehensive Drainage Study*

# Preliminary Engineering Report

Prepared for  
**City of Mechanicville**  
Mechanicville, New York

August 2024

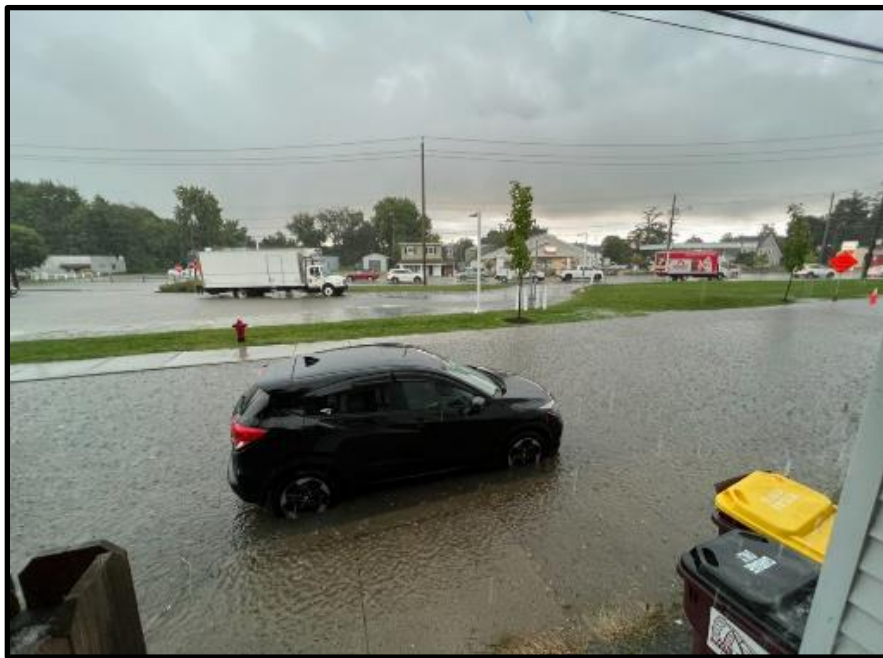
- On 1<sup>st</sup> Avenue directly across from the Cumberland Farms, extreme flooding occurs during heavy rain events due to trash and debris flow from other streets clogging drainage pipes and catch basin grates. **Figure 1** below shows floodwater spilling over the curb onto the sidewalks on both sides of the road. It also appears that this closed drainage system is significantly undersized.

**Figure 1.** Flooding on 1<sup>st</sup> Avenue spilling onto the sidewalks.

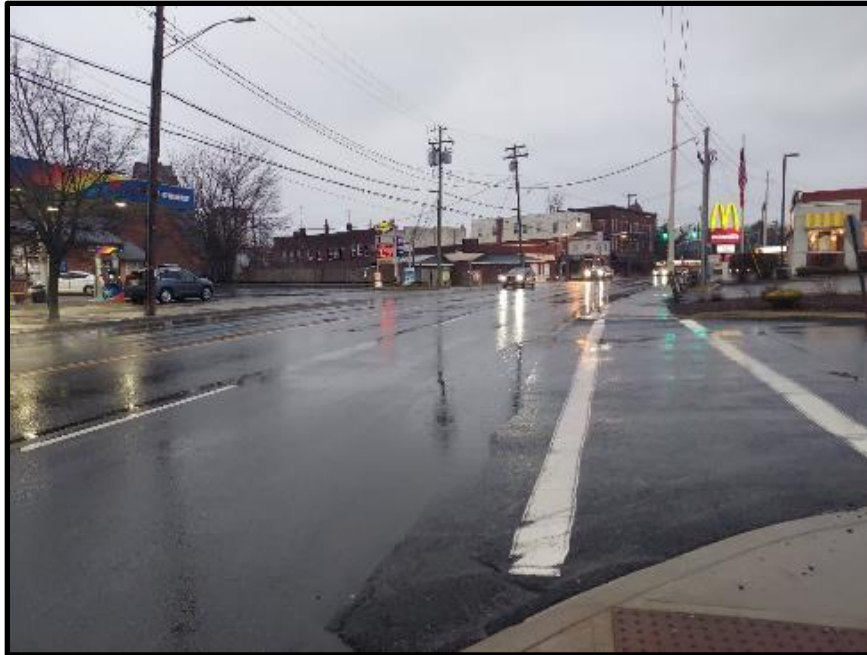
- The Park Plaza Shopping Center entrance located along North Central Avenue experiences ponding during significant rain events. See **Figure 2** below.

**Figure 2.** Ponding at the entrance to Park Ave Plaza.

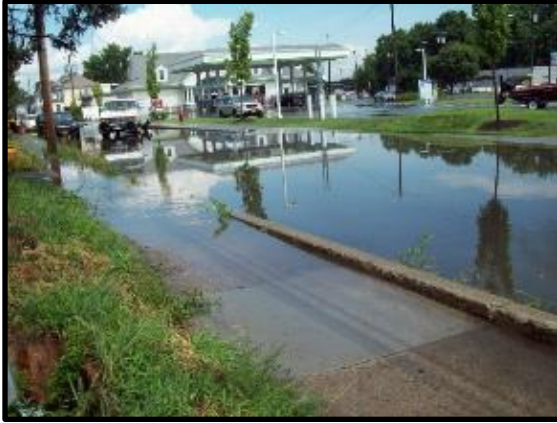
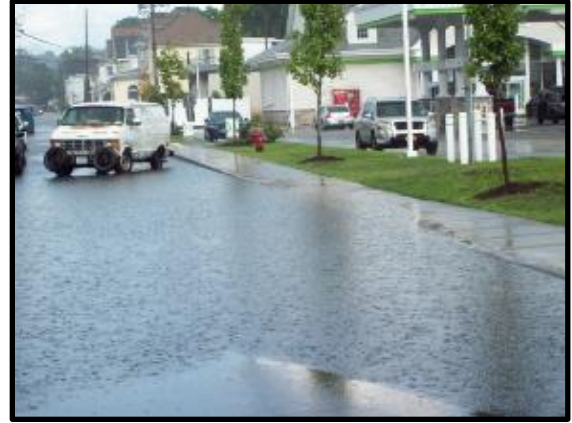
**Issue:** For several years, 1<sup>st</sup> Avenue has regularly experienced flooding issues. **Figures 3 and 4** below show the substantial ponding of water at the intersection of 1<sup>st</sup> Avenue and South Street that can occur after heavier rainfall events. The amount of water that ponds in the intersection of these streets can lead to hazardous road conditions for drivers that could be damaging to vehicles, lead to a loss of steering control, and an increased risk of hydroplaning. During winter months, ponded water freezes and causes hazardous icy conditions that can be dangerous for pedestrians. In particular, the roadway needs to be closed for periods of time, impacting emergency services response events.

**Potential Solution:** The existing infrastructure along 1st Avenue is made up of a mix of pipe sizes ranging from 12” to 18” in diameter. Through aerial mapping and field investigations, a drainage area of approximately 18 to 22 acres drains through the 1st Avenue system. The existing 18” pipe has slope runs as shallow as 0.23%. The theoretical capacity of this run of 18” storm pipe is approximately 5 cfs. The runoff rate for 18 acres in residential urban areas for a 1-year storm event is more than 23 cfs; and is more than 42 cfs during a 10-year storm event. This demonstrates that even in low storm events, the infrastructure along 1st Avenue is severely undersized to handle existing flows.

**Figure 3.** Flooding at Southern end of 1st Avenue.

**Figure 4.** Alternate view of flooding at Southern end of 1st Avenue.

The infrastructure leading into and along 1st Avenue should be further analyzed, and the undersized drainage infrastructure should be replaced to increase the stormwater conveyance capacities of the system. It is generally an acceptable engineering practice to size storm drains to safely convey a 10-year storm event. Increasing the existing 18” storm drainage piping to 36” HDPE piping at a 0.5% slope would sufficiently increase the capacity of the system to manage the 10-year storm event for this area. There is also potential to create a new pipe network that conveys drainage from this area more directly to the Hudson River via South Street, Ellsworth Avenue and Underwood Avenue, which could help to alleviate flooding in other adjacent downstream areas.

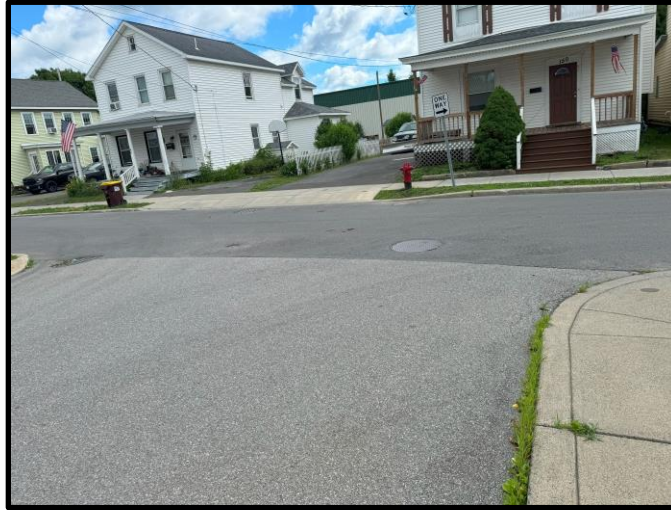
**Issue:** After heavy rainfall events, the catch basin at the intersection of Spring Street and 1st Avenue does not adequately drain and causes ponding of stormwater in the area. In the winter months, this area of the road becomes hazardous due to the ice that forms from the ponded water freezing. The pipes connecting into the catch basin may be clogged and are unable to properly allow the stormwater to flow through the pipe.

**Figure 5.** Intersection of Spring Street and 1st Avenue.

**Potential Solution:** Further field investigation and analysis is needed to determine if there are any blockages in the pipes. If sediment or debris accumulations are encountered, clearing the blockage(s) using high-pressure water jets and vacuum equipment may help to mitigate the flooding issues around this catch basin. The City could then develop a maintenance schedule to ensure that the catch basin is regularly cleaned to remove debris, sediment, or trash build up; to identify and address any potential system blockages prior to flooding issues arising.

If no blockages are found in the pipes, additional catch basins or larger diameter piping could be installed to allow a larger volume of runoff to enter and be adequately conveyed through the system.

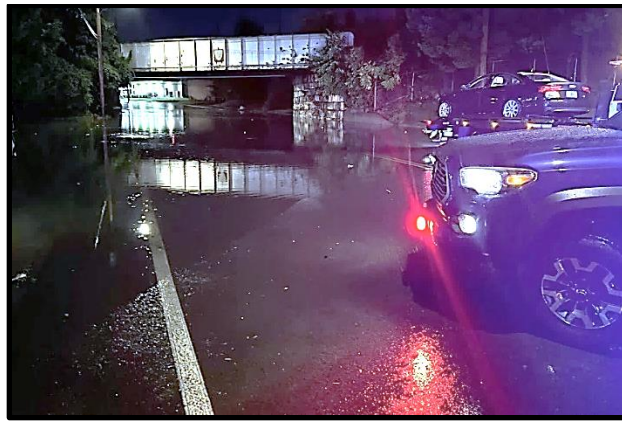
**Issue:** After heavy rain events, the catch basins underneath the existing railroad bridge over South Central Avenue at times become backed up with stormwater, causing substantial flooding (See **Figure 6**). There have been reported incidents where stormwater flooding extends to the existing Dunkin Donuts, located over 200 feet to the Northeast. Back-to-back storm events can be particularly problematic for this area because they exacerbate the limitations of the current piping and catch basins and can lead to increased flooding and road hazards.

The flooding is very hazardous to drivers and local police are often needed to blockade the easternmost northbound lane so vehicles do not drive through the flooded lane. As shown in **Figure 6**, cars can become stranded or disabled and then need to be towed out of the flooded area. Barton & Loguidice, D.P.C. (B&L) has designed and overseen the installation of two overflow systems to alleviate some of the flooding issues in this area in recent years for smaller storm events. It was reported by the DWP superintendent that a potential cause of the backup has been debris clogging the inlets along central.

**Figure 6.** Flooding underneath existing railroad bridge over South Central Avenue that resulted in a disabled vehicle needing to be towed.

**Potential Solution:** Further field investigation and analysis is needed to determine if the pipes along South Central Avenue/North Central Avenue that flow north to Anthony Kill have sufficient capacity to handle the amount of stormwater that ultimately drains through this system, particularly during the larger and higher intensity storm events. Based on available data, the existing piping along this system ranges from 15"-24". This range of pipe sizing may be inadequate and could require replacement to have sufficient capacity to convey all of the runoff that drains through this system, while also would help to alleviate any backup in the system.

It is also important to ensure there is no debris accumulated on or near the catch basin grates that could result in blockages that prevent stormwater from entering the system. It would be beneficial to check the catch basin grates for accumulated debris after heavy storm events at frequently flooded locations to clean the debris prior to the next storm event. It is possible that installing different types or sizing of grates on the existing catch basins could help mitigate this issue. Another solution to reduce trash and debris accumulation in the catch basins could involve the city conducting more regular street sweeping activities.

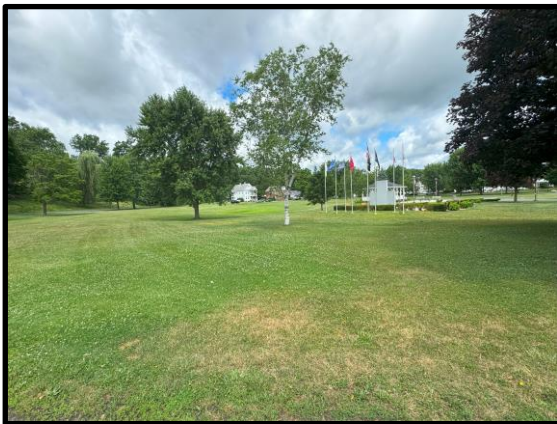
**Issue:** There have been numerous occasions of Tallmadge Park significantly flooding after heavy rainfall events. Stormwater collects in low areas of the park and remains for several days, reducing the availability of select park areas until it dries out. The park is a key recreational area in the City of Mechanicville and is used by many community members, making it a priority area in need of drainage improvements. **Figures 7-11** below show low points in the park where water frequently pools after heavy storm events and the water typically remains in those areas for several days.

There currently exists one catch basin in the middle of the field of Tallmadge Park, west of the existing monument and gazebo. When field observations were made following a rain event, the catch basin was full and water appeared stagnant. The area of the park near the wooded area behind the fountain often floods due to the water flowing down the steep hill between the park and the retaining wall along the road on South Street.

**Figure 7.** Area in Tallmadge Park that remains wet for several days after heavy rain events.

**Potential Solution:** There is insufficient storm drainage throughout Tallmadge Park. The terrain in the park is undulating with many low-lying areas lacking drainage infrastructure. Since there is currently a lack of drainage structures in the park, it is possible that an underdrain system installed throughout the park could more effectively manage the stormwater runoff and reduce the amount of time it takes for the field to dry and be usable. Low-lying areas of the park could be regraded with additional topsoil fill to eliminate these low points and help mitigate the stagnant water issues. Storm infrastructure could then also be added to further help address these concerns.

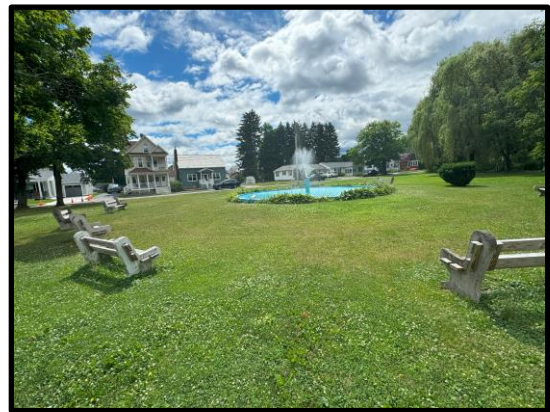
**Figure 8.** The grass near the fountain at the southern part of Tallmadge Park frequently floods.

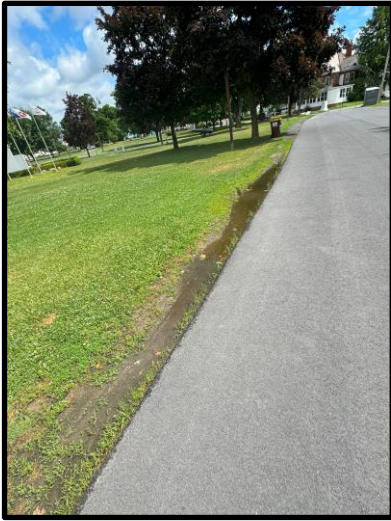
**Figure 9.** Flooding along the edge of Park Place and the grass at the park.

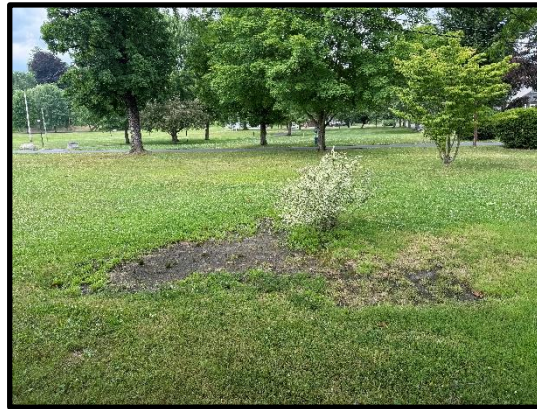
**Figure 10.** Low point at the northeastern corner of the Park that floods.

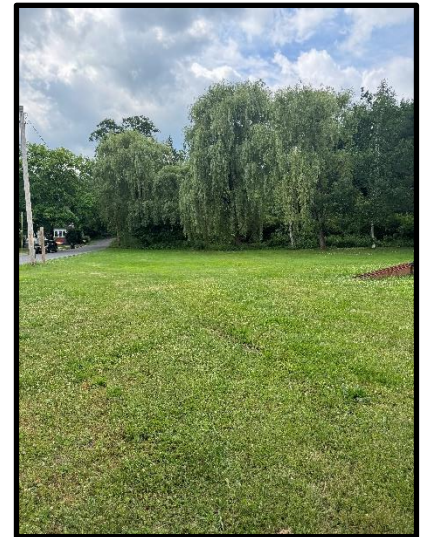
**Figure 11.** The grass area east of the fountain that frequently floods.

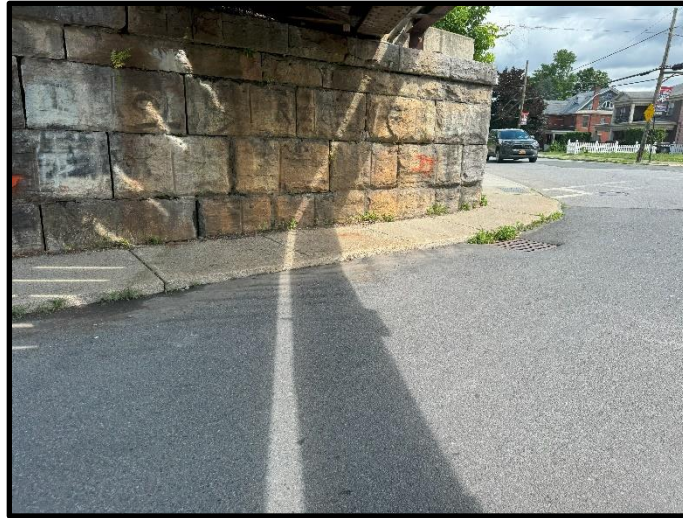
**Issue:** After heavy rainfall, water ponds around the catch basin underneath the existing railroad bridge at the intersection of Ellsworth Ave and South Main Street (See **Figure 12**). The pipes connecting to the catch basin may be clogged, or the pipes may not be adequately sized to manage the full volume of stormwater that drains to this area. During winter this area becomes hazardous as the ponded water freezes, creating ice on the road.

**Figure 12.** Catch basin underneath existing railroad bridge at the intersection of Ellsworth Ave and South Main Street.

**Potential Solution:** To mitigate flooding around the catch basin, first determine if the pipes are blocked and clear any blockages using high-pressure water jets and vacuum equipment. Regularly clean the catch basin to remove debris, sediment, and trash. Schedule routine inspections to identify and address potential issues before flooding occurs. If no blockages are found, consider installing additional catch basins to distribute the water load or increasing the pipe sizes to accommodate higher water volumes. As mentioned previously there also may be potential to create a new pipe network that conveys drainage from this area directly to the Hudson River via Ellsworth Avenue and Underwood Avenue. This system could ultimately connect to a proposed system at the intersection of 1<sup>st</sup> Avenue and South Street, which could then help to alleviate flooding in other downstream adjacent areas as well.

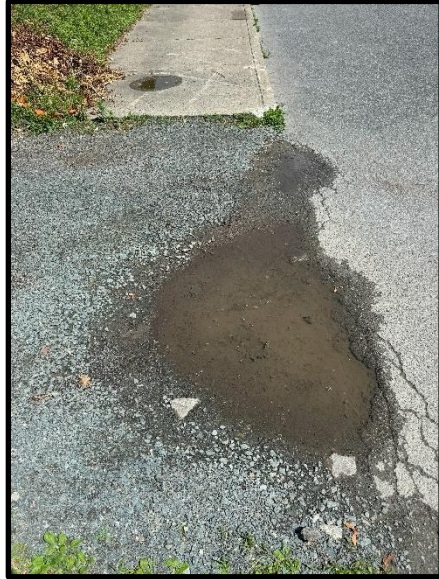
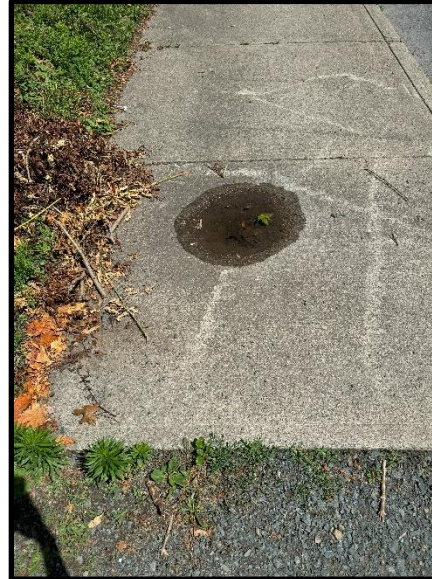
**Issue:** Various locations along South Main Street experience flooding after rain events such as areas South of Riverside Park S., adjacent to Paul Luther Memorial Park and Playground, and between Alexander J. Avenue and Arnold Avenue. Low points along the sidewalk and the edges of the driveways along the road flood and have stagnant water remain for days after a storm event. The existing railroad tracks west of the South Main Street act as a drainage divide and runoff from the embankment flows through adjacent property owners' yards and collects at the low points along the road as shown in the **Figures 13 to 17** in Sections 4.6.1, 4.6.2 and 4.6.3 below. There is also a notable lack of drainage infrastructure along this stretch of South Main Street. Due to the frequent ponding of water, the pavement in the low points is deteriorating resulting in costly upkeep.

**Figure 13.** Ponding at the edge of a driveway along South Main St. South of Riverside Park South.

**Figure 14.** Ponding along the sidewalk along South Main St. South of Riverside Park South.

- To reduce the ponding of water, the road should be regraded and resurfaced when the roadway needs to be rehabilitated to eliminate the low points in the road and promote positive drainage. When the City updates their annual roadway paving priority listing, this area may need to be considered sooner rather than later for rehabilitation.

- Installing drainage devices near the railroad tracks could help to reduce runoff flowing through adjacent property owner's land and collecting along the road.
- Another option could involve installing drainage structures along the road in the locations that are currently experiencing flooding to capture and convey runoff to a controlled discharge location, likely to the Hudson River.

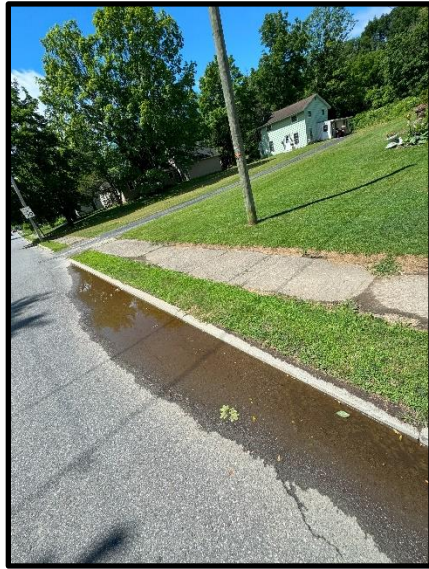
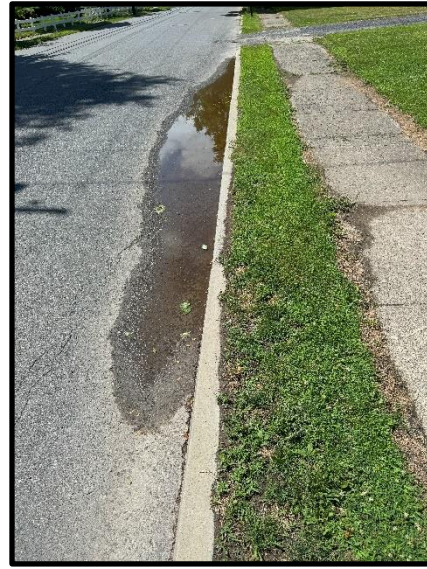
**Figure 15** Ponding at the edge of a curb along South Main St. near Paul Luther Memorial Park and Playground.  
South of Riverside Park South.

**Figure 16.** Alternate view of ponding at the edge of a curb along South Main St. near Paul Luther Memorial Park and Playground.  
South of Riverside Park South.

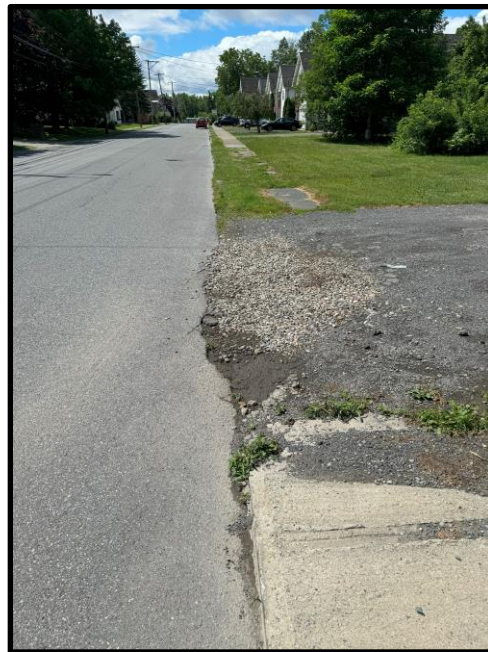
**Figure 17.** Remnants of ponding at the edge of a driveway along South Main St. between Alexander J. Avenue and Arnold Avenue.

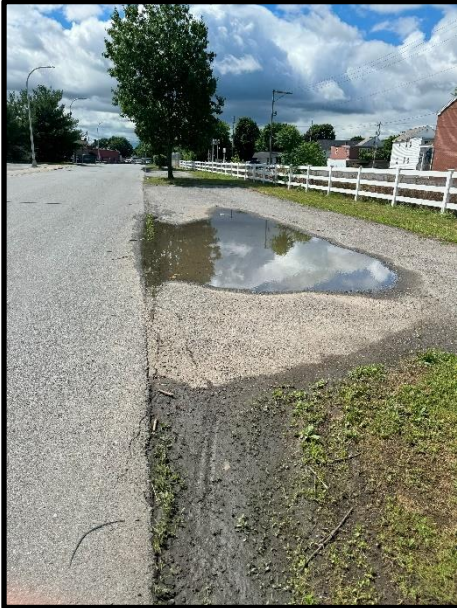
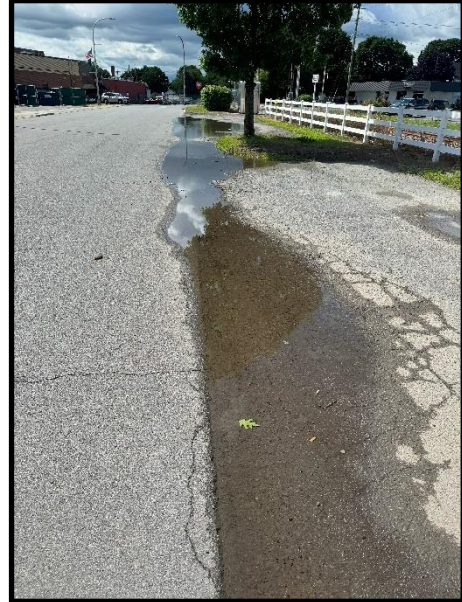
**Issue:** On the western side of Railroad Street there are frequent stormwater ponds and remains for several days after rainfall events. There is “alligator cracking” of the pavement observed in the low points in the road where the stormwater ponds and does not drain. There are currently no drainage structures on Railroad Street between Park Avenue and Broadway. During large storm events ponding of water creates a safety hazard for drivers, especially in the winter months when the water freezes and leads to icy road conditions.

**Figure 18.** Ponded stormwater observed along the side of Railroad Street.

**Figure 19.** Ponded stormwater and “Alligator cracking” observed along the

**Potential Solution:** It would be recommended to repair the alligator cracking as it will worsen over time. Increased water penetration/degradation of the pavement layers, and freeze-thaw cycles, will cause the cracks to expand and will leave voids in the pavement structure causing it to weaken further. The damaged pavement should be excavated and removed, as well as any unstable or weak base material. These areas should be regraded to eliminate the low points and ensure that there is positive drainage. Upon further analysis, installing drainage infrastructure along this strip of the road could be considered to prevent future stormwater ponding, extend the pavements’ lifespan, and provide safer driving conditions.

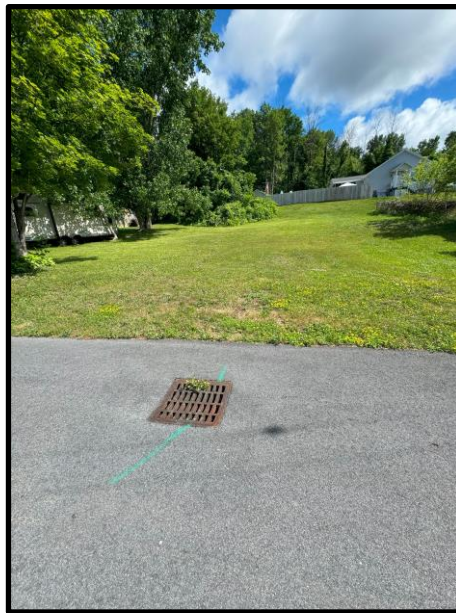
**Issue:** There have been several occurrences of flooding around the catch basin on Walnut Street West of Pittsburgh Avenue. This catch basin collects runoff from upgradient areas to the north. The catch basin and associated piping may not be adequately sized to manage all of the stormwater runoff flowing to it; or the outflow piping may be damaged or clogged.

**Figure 20.** Catch basin on Walnut Street West of Pittsburgh Ave with the upgradient drainage area in the background.

**Potential Solution:** Further inspection of the catch basin and outflow pipes is needed to ensure they are in good condition and working properly. If so, analysis of the flow capacity should be conducted to determine if increasing the size of the outlet piping or another drainage structure is recommended to capture all of the stormwater runoff flowing to this area and reduce ponding of water during large rainfall events.

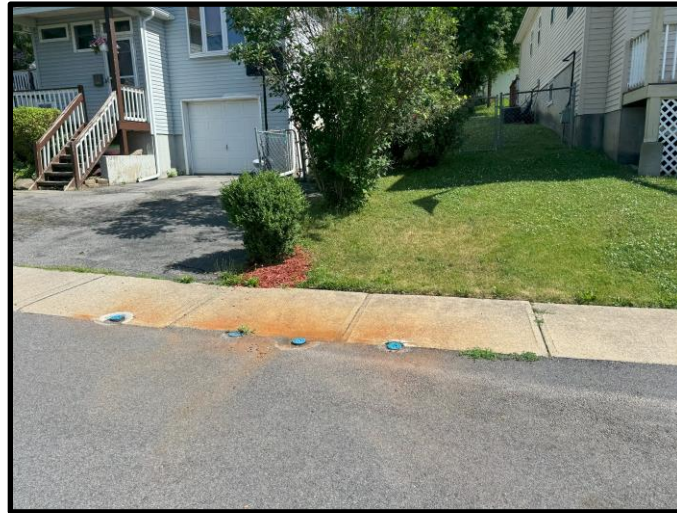
**Issue:** There is a low point between the sidewalk and edge of road where the stormwater runoff from upgradient areas collects and does not drain.

**Figure 21.** Area with evidence of ponded stormwater on Walnut Street Between Pittsburgh Ave and New York Ave.

**Potential Solution:** Upon further analysis, it may be recommended that a drainage structure be installed and connect it into existing drainage infrastructure along Walnut Street to reduce ponding in this area.

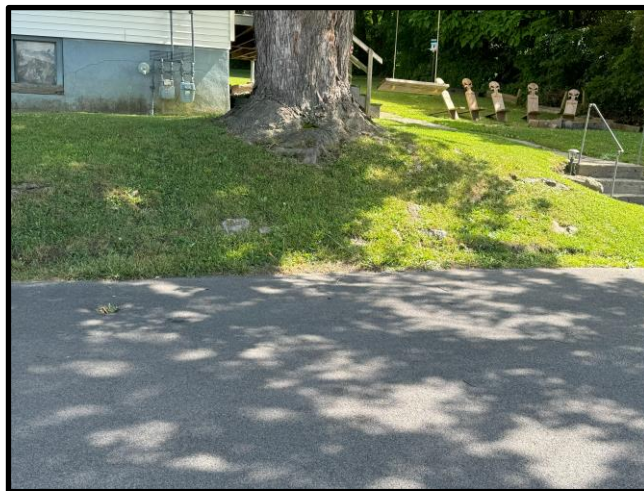
**Issue:** Stormwater runoff from upgradient areas ponds in this general vicinity and does not drain due to the existing topography being relatively flat and there is no drainage infrastructure in close proximity.

**Figure 22.** Area with evidence of ponded stormwater on Walnut Street Between New York Ave and Philadelphia Ave.

**Potential Solution:** Upon further analysis, it may be recommended to install a catch basin in this area to collect the stormwater runoff from the upgradient areas.

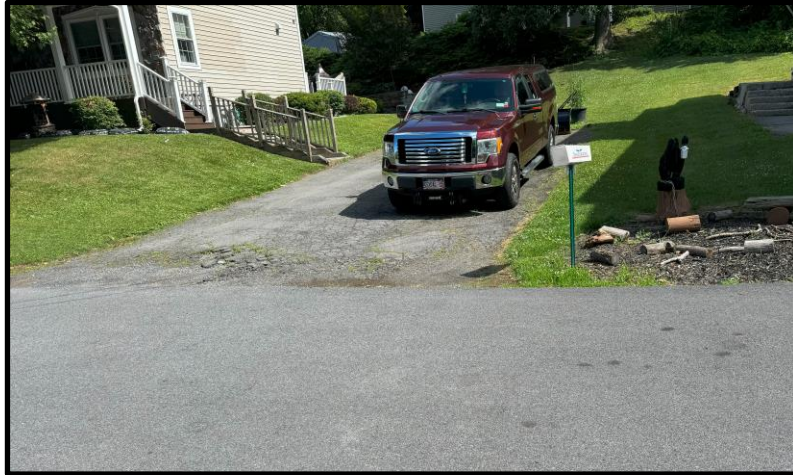
**Issue:** Stormwater runoff flows down the homeowner's driveway and collects at the bottom of the driveway at the edge of the road.

**Figure 23.** Area where stormwater runoff ponds at the end of the residential driveway on Walnut Street.

**Potential Solution:** Upon further analysis, it may be recommended to install drainage infrastructure to collect stormwater in this area or raise the grade of the driveway to meet the edge of road asphalt pavement so the stormwater runoff flows to the nearest catch basin.

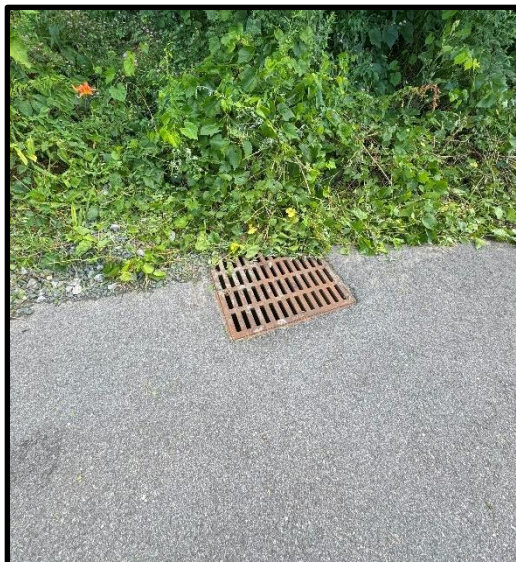
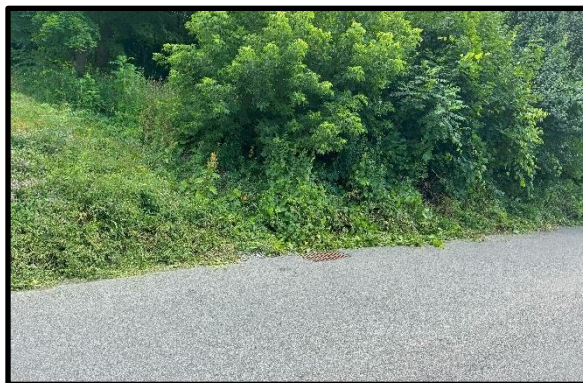
**Issue:** After heavy rainfall events, stormwater runoff ponds at the catch basin on Warsaw Ave between Farrell and Maple Streets. The pipes connecting into the catch basin may be clogged and are unable to properly manage the runoff. In the winter months, this area of the road becomes hazardous due to the ice that forms from the ponded water freezing.

**Figure 24.** Catch basin on Warsaw Ave between Farrell and Maple Streets.

**Figure 25.** Alternate view of catch basin on Warsaw Ave between Farrell and Maple Streets.

**Potential Solution:** Further inspection of the existing infrastructure is needed to determine if there are any blockages in the pipes. If debris or sediment accumulation is found, the blockage(s) could be cleared by using high-pressure water jets and vacuum equipment. The City could then develop a maintenance schedule to ensure that the catch basin is regularly cleaned to remove debris, sediment, or trash build up; to identify and address any potential system blockages prior to flooding issues arising.

If no blockages are found in the pipes, additional catch basins or larger diameter piping could be installed to allow a larger volume of runoff to enter and be adequately conveyed through the system.

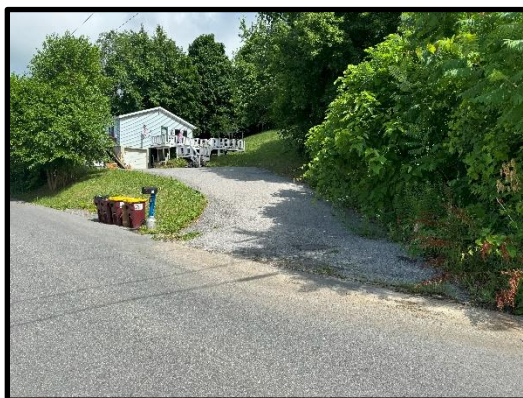
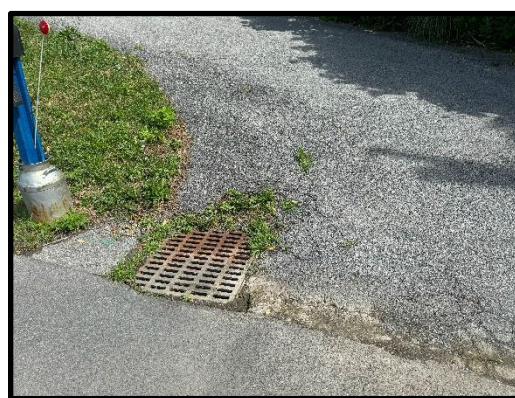
**Figure 26.** Area where stormwater runoff ponds at end of residential driveway at intersection of Warsaw Ave and Maple Street.

**Figure 27.** Close up of catch basin at end of residential driveway at intersection of Warsaw Ave and Maple Street.

**Potential Solution:** Further inspection of the outflow pipe is needed to ensure that it is not clogged or damaged. If no blockages are found, it may be recommended to install an additional catch basin on the opposite side of the driveway to collect the flow that does not drain into the existing catch basin.

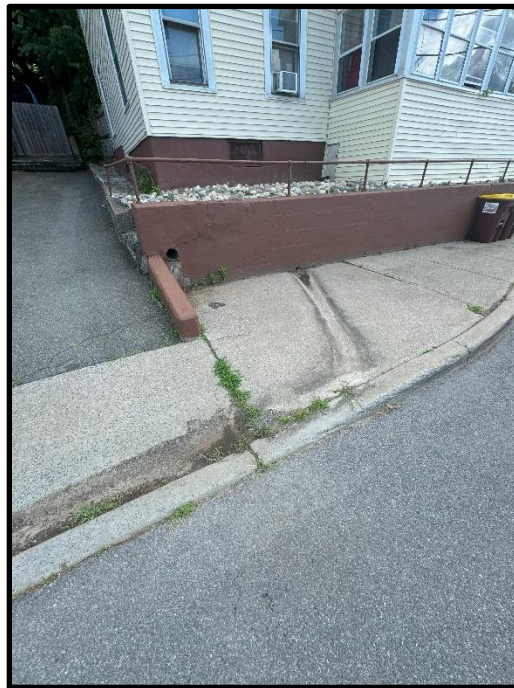
**Issue:** Stormwater runoff flows down the sidewalk and flooding the sidewalk, edge of the road, and bottom of the driveway on the north side of the intersection of Warsaw Avenue and Leonard Street. During heavy storms, the water ponds on the sidewalk and road and in the winter the water turns to ice, causing safety hazards.

**Figure 28.** Area on the north side of the intersection of Warsaw Ave and Leonard Street where stormwater ponds.

**Potential Solution:** Upon further analysis it may be recommended to install additional drainage infrastructure at the edge of the curb where the stormwater runoff ponds to help prevent hazardous road and sidewalk conditions in this area.

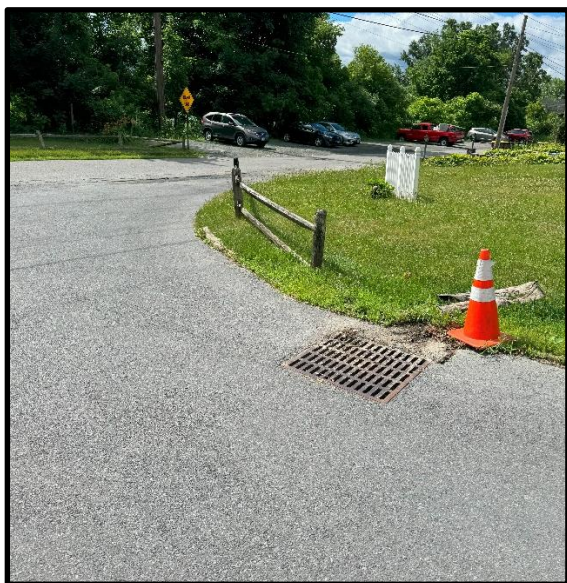
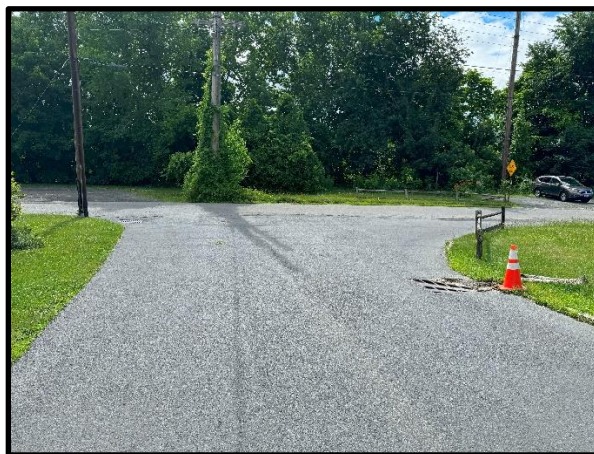
**Issue:** After heavy rainfall events, the catch basin on the south side of Warsaw Avenue at the intersection of Mulberry Street ponds stormwater runoff. It is possible that the pipes connecting into the catch basin may be clogged and are unable to properly manage the runoff flowing to the structure. In the winter months, this area of the road becomes hazardous due to the ice that forms from the ponded water freezing.

**Figure 29.** Close up of catch basin where stormwater ponds at intersection of Warsaw Ave and Mulberry Street.

**Figure 30.** Intersection of Warsaw Ave and Mulberry Street.

**Potential Solution:** Further inspection of the existing infrastructure is needed to determine if there are any blockages in the pipes. If debris or sediment accumulation is found, the blockage(s)

If no blockages are found in the pipes, additional catch basins or larger diameter piping could be installed to allow a larger volume of runoff to enter and be adequately conveyed through the system.

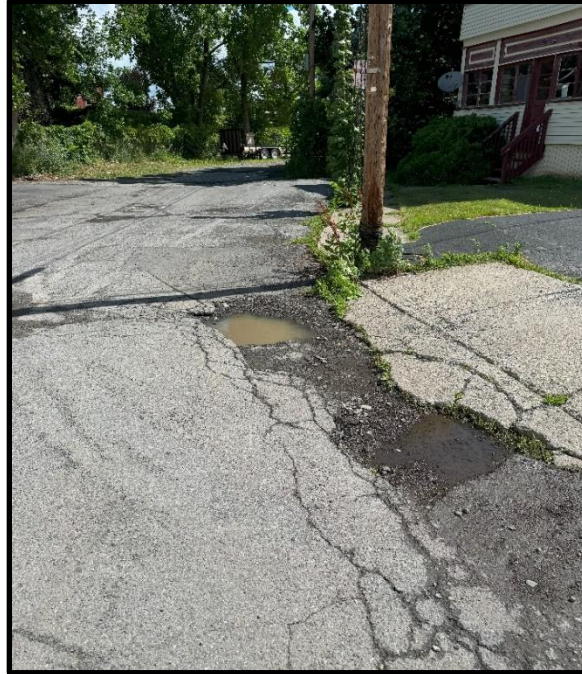
**Issue:** Significant “alligator cracking” and pavement degradation exists at the north end of Penrose Avenue as a result of frequent ponding of water and lack of drainage. Stormwater frequently ponds throughout the area in the low points of the road and is reducing the pavement integrity and accelerating the alligator cracking. There is also an existing pothole near the utility pole that holds water when it rains.

**Figure 31.** Pothole and “Alligator cracking” at North end of Penrose Ave.

**Potential Solution:** It is recommended to repair the pothole and remove and replace the sections of asphalt affected by alligator cracking. Inspection and repair of the subbase and subgrade layers to ensure adequate thickness for base layers and pavement layers would also be recommended. Upon further analysis it may be recommended to install a drainage structure in this area to collect the stormwater runoff to prevent alligator cracking and water accumulation in the future.

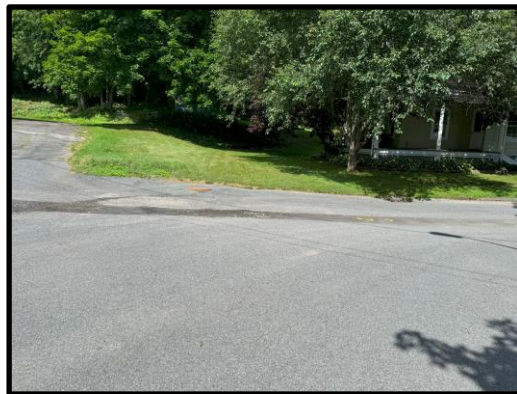
**Figure 32.** Area where stormwater ponds on the Southwest side of the intersection of N 8th Ave and Broadway.

**Potential Solution:** Upon further analysis it may be recommended to install a catch basin in this area and tie it into the existing stormwater infrastructure in the area.
